RE: Attached FEMA Report Excerpts

BUILDING PERFORMANCE: HURRICANE ANDREW IN FLORIDA

OBSERVATIONS, RECOMMENDATIONS,
AND TECHNICAL GUIDANCE

DECEMBER 21, 1992

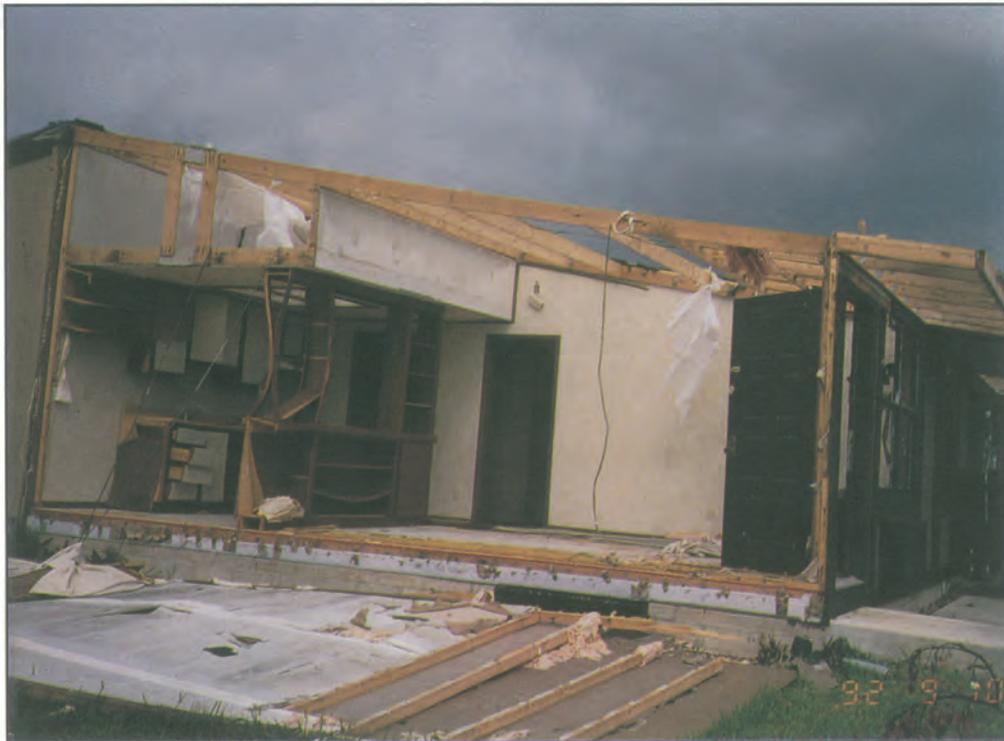
Two end-wall (end wall of end modules) failures were observed in a modular home subdivision. Poor connection of the tops of the walls to the roof diaphragms was evident in these instances. Some roof sheathing was observed missing from rafters, judged to be due either to building envelope breach (window and/or door failure) or to external wind and debris. Generally, the rafters themselves were left entirely intact, because of the inherent rigidity developed by the relatively short spans and secure connections. (SEE FIGURES 19 AND 20.)

FIGURE 19. *Modular home. End wall of end unit separated from unit; withdrawal of nails along eave line and roof sheathing failure were also observed.*

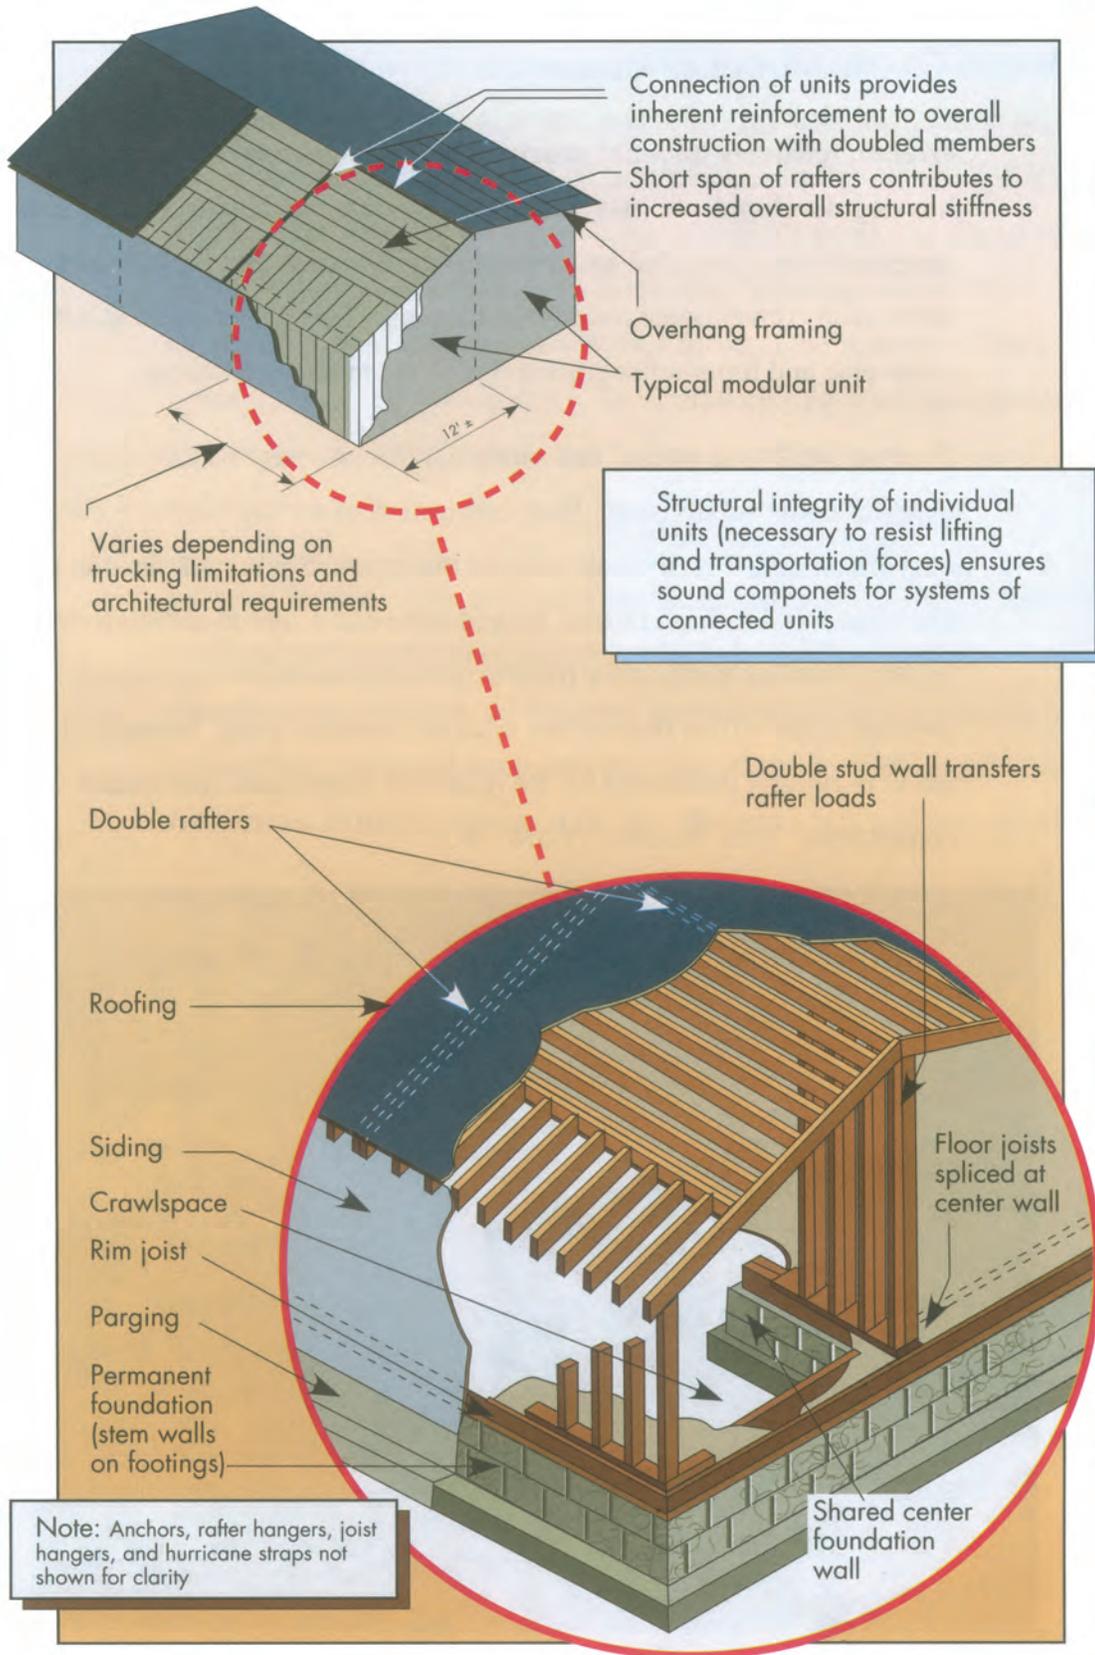
Overall, relatively minimal structural damage was noted in modular housing developments. The module-to-module combination of the units appears to have provided an inherently rigid system that performed much better than conventional residential framing. This was evident in both the transverse and longitudinal directions of the modular buildings.

FIGURE 20. *Inherent structural strength of modular construction.*

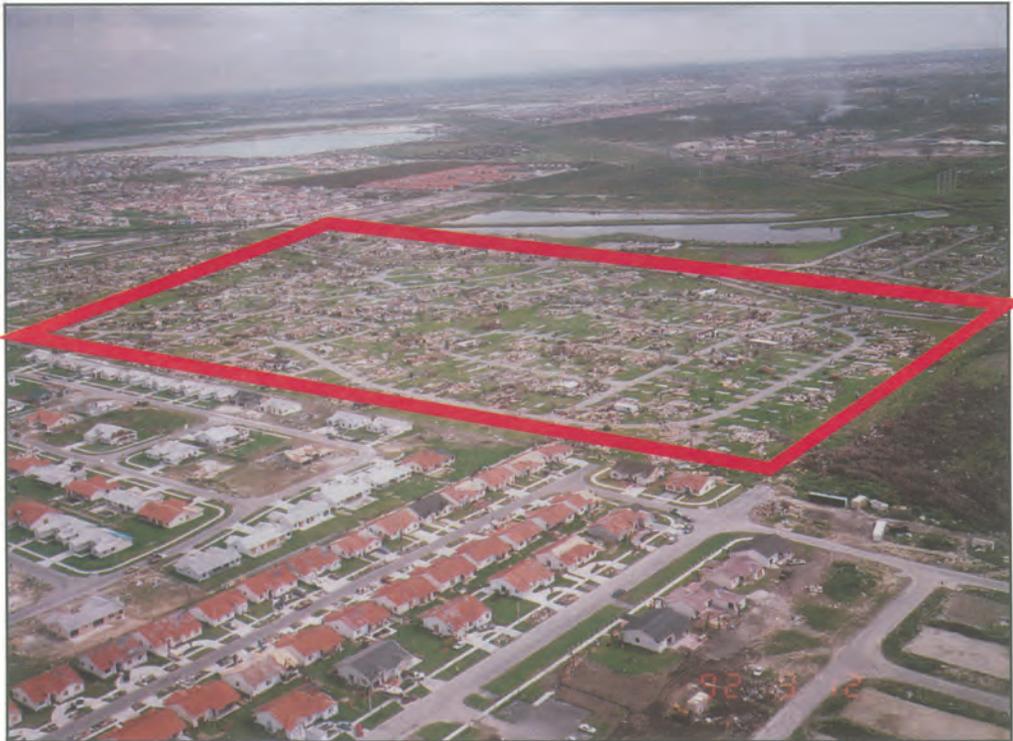
Manufactured homes possessed poor ability to withstand the high wind loads generated by Hurricane Andrew (SEE FIGURE 21). In several subdivisions, many of these homes suffered total losses.

It was observed that the breakup of corrugated metal siding and roofed buildings such as manufactured homes and pre-engineered metal frame buildings contributed significantly to the generation of airborne debris. This was evident from debris damage to nearby downwind structures.

FIGURE 21. Aerial photo of damage area. Shows building performance difference between manufactured homes (outlined in center) and conventional residential buildings (lower left).
